Official Accident Report Index Page

Report Title

ATLANTIC SOUTHEAST AIRLINES, INC., FLIGHT
529 EMBRAER EMB-120RT, N256AS CARROLLTON,
GEORGIA AUGUST 21, 1995

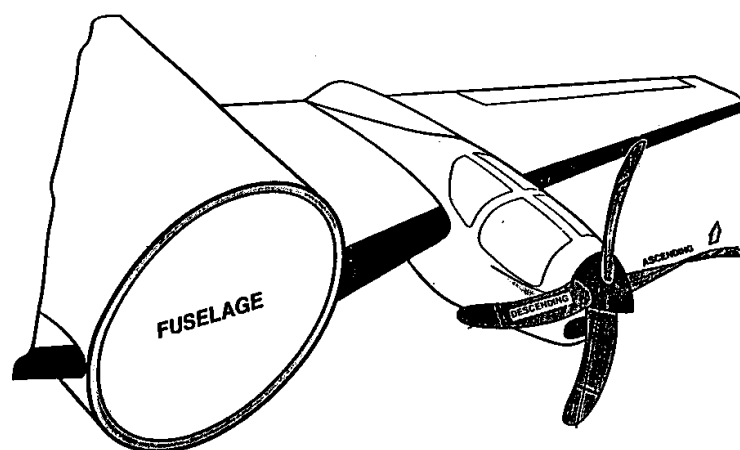
Figure 1.--Propeller installation - left wing.

Investigators found the left engine propeller assembly early in the ground debris path. The propeller hub contained three complete blades and about 1 foot of the inboard end of the fourth blade protruding from the hub. The remainder of the fourth blade was not at the accident site. (See Section 1.12 for more wreckage information.)

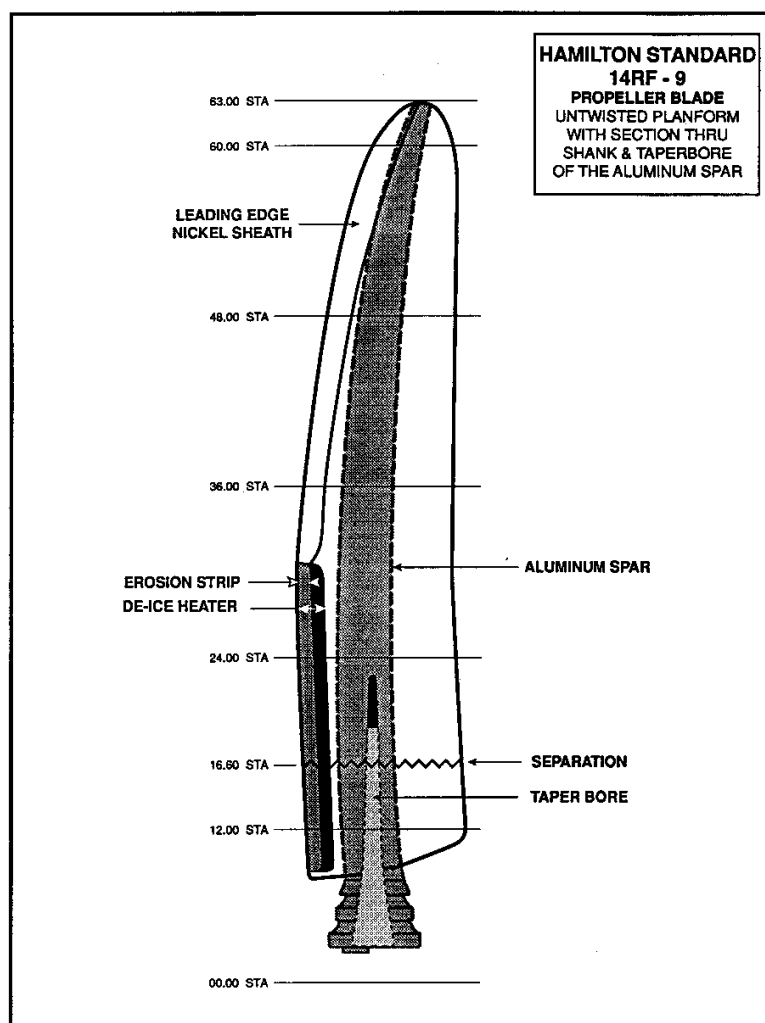
Figure 2.--Illustration of a 14RF-9 propeller blade.

Hamilton Standard manufactures a family of composite propeller blades, including the 14RF (the accident propeller blade), 14SF, and 6/5500/F, that are intended for use on turbopropeller commuter airplanes. The solid, forged 7075-T73 aluminum alloy spar is the main load-carrying member. The airfoil shape of the blade is formed by glass fiber-filled epoxy and foam adhesively bonded to the spar (see Figure 2). A conical hole (taper bore) is bored in the center of the spar from the inboard end to blade station 21, [12](#) for weight reduction and balance weight installation. The taper bore on the 14RF blade can be one of two different shaped designs: straight taper bore known as the "M" style [13](#) and a bellmouth shape (known as the "N" style). Also, during very early production, the taper bore was shotpeened. [14](#) However, early in the production run, Hamilton Standard reviewed the production process, deemed shotpeening unnecessary, and, with FAA approval, it was discontinued. The accident blade was originally an N style blade, but it was rebalanced on customer request for ASA fleet standardization to the M style and reidentified as an M blade. The accident blade taper bore was not shotpeened during production.

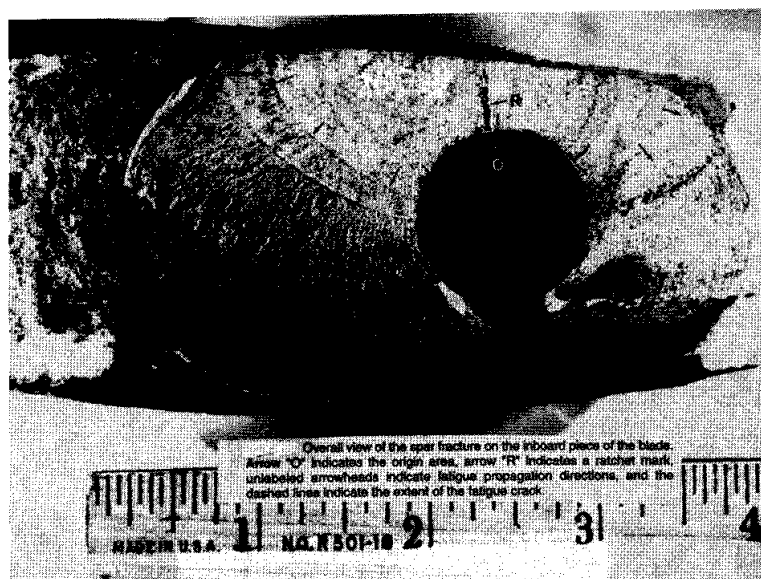
Figure 3.--Photo of the blade fracture surface.

The inboard piece of the fractured blade, serial number 861398, was retained in the left engine propeller hub, which was recovered at the accident scene on August 21, 1995. The outboard piece of the blade was recovered on September 15, 1995, after it was discovered by a farmer on property about 35 miles west of the accident site adjacent to an area that had previously been searched by helicopter. Both portions of the blade were examined at the Safety Board's Materials Laboratory. The blade spar²⁵ was separated at blade station 16.6 (about 13.2 inches outboard of the blade pin platform). Initial visual examination revealed that a portion of the spar fracture was on a flat transverse plane and contained crack arrest positions, typical of fatigue cracking (see Figure 3). The fatigue cracking appeared to initiate from at least two adjacent locations on the taper bore surface. Below the taper bore surface, the individual cracks joined to form a single crack that propagated toward the face side²⁶ of the blade and progressed circumferentially around both sides of the taper bore. The extent of the fatigue cracking progressed through about 75 percent of the spar cross section. The fracture surface in areas beyond the terminus of the fatigue region contained rough features with a matte appearance, typical of an overstress separation area.

The origin areas on both the inboard and outboard faces of the fracture were examined with a scanning electron microscope (SEM) before the faces of the fracture were cleaned. The fracture surface near the origin area on both faces of the fracture contained a layer of heavy oxide deposits that had a mud-cracked appearance. These deposits extended to a maximum depth of 0.049 inch from the taper bore surface. Their maximum circumferential width was 0.130 inch, based on the examination of the damaged outboard fracture face. X-ray energy dispersive spectroscopy (EDS) of the deposits of both faces generated similar spectra with a major peak for aluminum, a substantial peak for oxygen, and a minor peak for zinc.²⁷ EDS of the deposit area on the inboard fracture face also revealed the presence of chlorine.

After the fracture surface had been cleaned, additional SEM examination revealed that the fatigue cracking initiated from several corrosion pits in a line of pits in the taper bore that extended over a distance of about 0.070 inch. The maximum depth of the corrosion pitting at the fatigue origin area was measured as slightly less than 0.006 inch below the taper bore surface.

The taper bore surface, including the area adjacent to the fatigue initiation area, contained a series of nearly circumferential sanding marks. The marks extended over about 180 degrees of the circumference of the taper bore and to a maximum distance of about 1.5 inches inboard of the fracture surface. Outboard of the fracture, the sanding marks extended about 2 inches from the fracture surface.

The investigation revealed that sanding rework of the area had been accomplished using the blending repair procedures contained in PS960A.²⁸ The procedures required that the surface finish of the blended area should be restored to the original surface finish. Postaccident surface profilometer measurements conducted on the taper bore sanding marks indicated that the surface finish was much rougher than the manufactured surface not disturbed by the rework process.²⁹ Measurements also indicated that the nondisturbed surface met the manufacturing specifications.

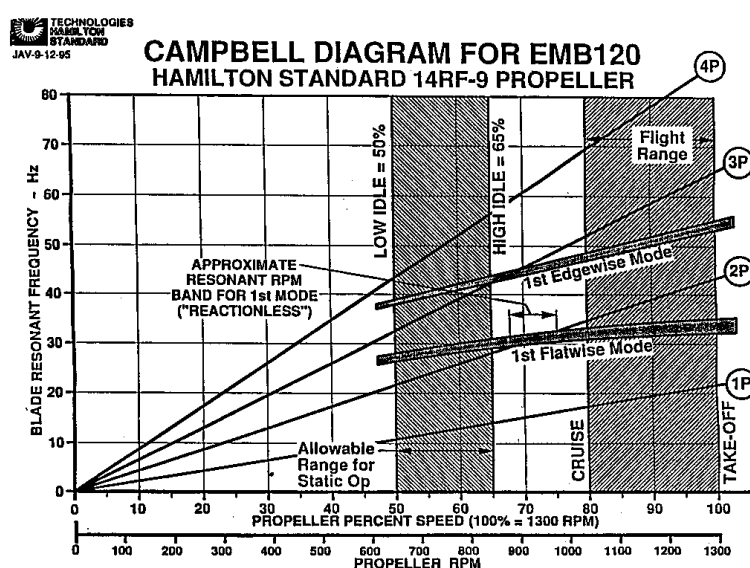
Figure 4.--Vibratory modes of the 14RF-9 propeller.

The Hamilton Standard 14RF-9 blade for the EMB-120 was designed so that its first flat-wise resonant frequency would not coincide with the 2P⁴⁸ excitation frequency during ground operation. However, the coincidence or close proximity of the ground rotational speed and the first flat-wise resonant frequency can place the propeller in a resonant condition and results in undesirable vibratory stress.^(See Figure 4 for an illustration of the vibratory modes of the 14RF-9 propeller.)

When the first flat-wise vibration frequency and the 2P excitation frequency coincide, a four-bladed propeller, such as the 14RF-9, vibrates in the reactionless⁴⁹ mode. The reactionless mode of vibration is characterized as when two blades of a four-bladed, rotating propeller, 180 degrees apart, reach a negative stress peak at the same time that the other two blades reach their positive stress peak. This type of propeller vibration is called reactionless because the bending loads of the four blades are canceled at the propeller hub which consequently transmits little or no vibratory loading to the propeller mounting structure.
